Royal Commission on the
Ocean Ranger Marine Disaster

**Report One: The Loss of the Semisubmersible
Drill Rig *Ocean Ranger* and its Crew**

The Royal Commission on the *Ocean Ranger*
Marine Disaster was jointly established and
funded by the Governments of
Canada and Newfoundland

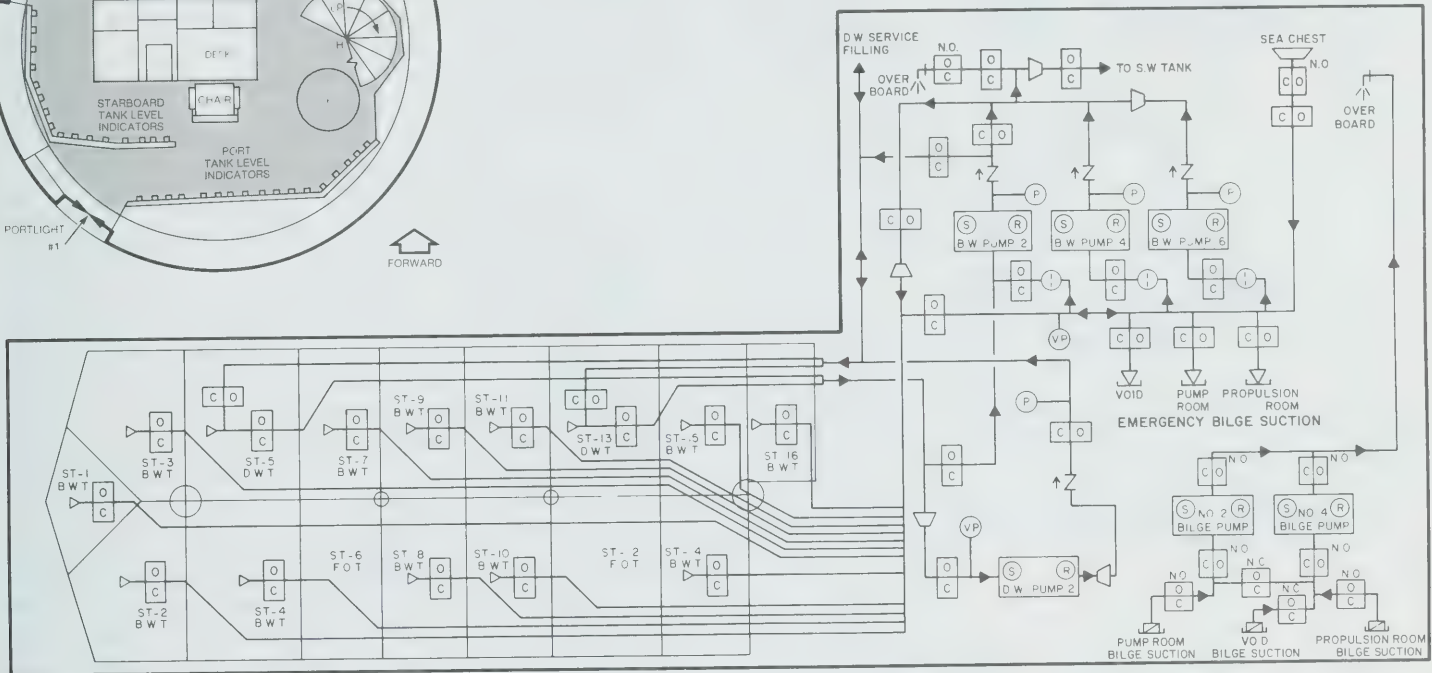
2.4 The ballast control room, 18 feet in diameter, was approximately 28 feet above the mean water level at the 80-foot drilling draft. The valves and pumps in the ballast system were controlled from the mimic panel, which provided a clearly labelled schematic representation of the system's components. The starboard section of the mimic panel is illustrated.

There is no evidence of serious problems with the ballast system during the rig's six-year operating history. The system worked well when the rig was level; it proved problematic, however, when the rig was trimmed by the bow. At a relatively moderate bow trim the suction limits of the pumps located in the stern of each pontoon were exceeded and the pumps were incapable of discharging ballast from the forward tanks.²

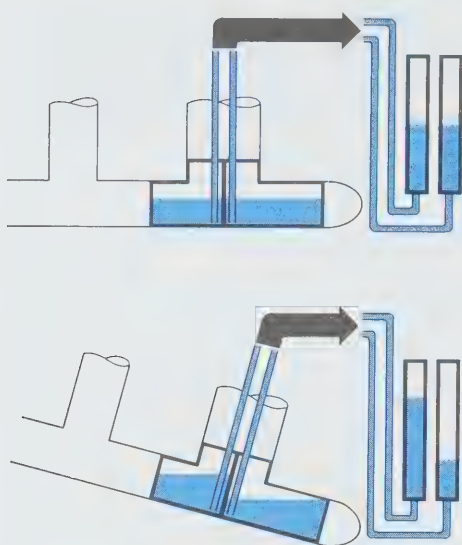
2.5 An accurate assessment of the weight carried in each pontoon tank was critical for the stability calculation. Substantial errors would be encountered if the rig was trimmed, as the conversion tables made no allowance for the position of the gauge's sensor tube.

Two sets of tank level gauges or "King gauges" located on the stern bulkhead of the ballast control room indicated the level of sea water ballast, fuel oil and drill water in the pontoon tanks. Conversion tables provided in the *Booklet of Operating Conditions*, were used by the ballast control operators in the calculation of the rig's stability. These conversion tables were accurate only when the rig was level and did not contain corrections to allow for trims to the bow or stern. The location of the King gauges' sensor tubes at the end, rather than at the centre, of each pontoon tank caused changes in the tank level readings when the rig was trimmed to the bow or stern. Therefore, the ballast control operator could misinterpret the tank contents when the rig was trimmed. Furthermore the gauges for the port pontoon were located on the starboard side of the ballast control room and the starboard gauges were on the port side. This confusing arrangement coupled with the possibility of misinterpreted tank contents could lead the operator to take inappropriate counter-measures to right the rig when it was trimmed.

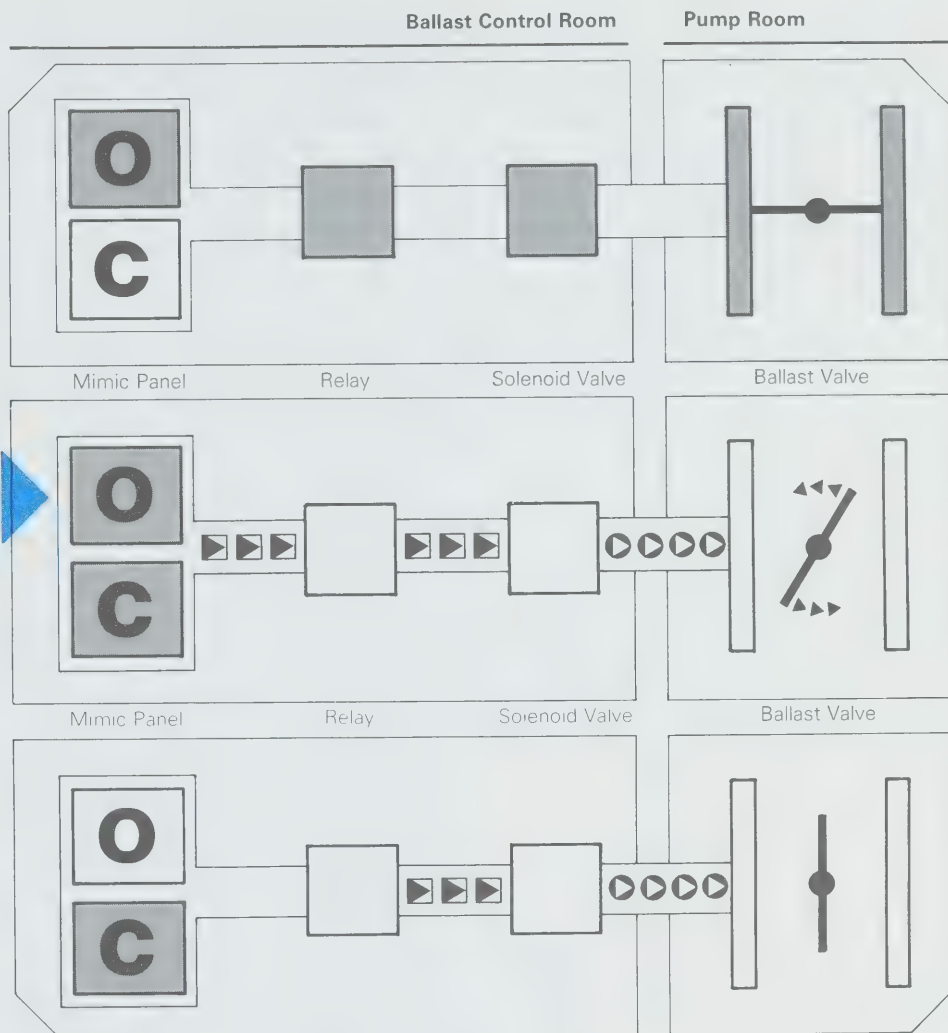
2.6 Ballast control operation using the mimic panel.

The indicator lights on the mimic panel showed only that a valve was completely open or completely closed. When an “open” switch was pressed, the “closed” indicator light (red) was extinguished immediately by the relay, and for the 20-40 second period that the valve was in motion no indicator was lit. When the valve moved to the fully open position, the “open” indicator (green) was lit. If both indica-

The mimic panel provided very limited information regarding the valves, and no information about the mechanical condition of the equipment. In the event of a mechanical failure in the valve control system, the operator could be presented with confusing or conflicting information. There was no method of ascertaining the direction of travel of the valves from the ballast control room. ODECO's original specifications did require a feature of this type but it was not included in the installed console.

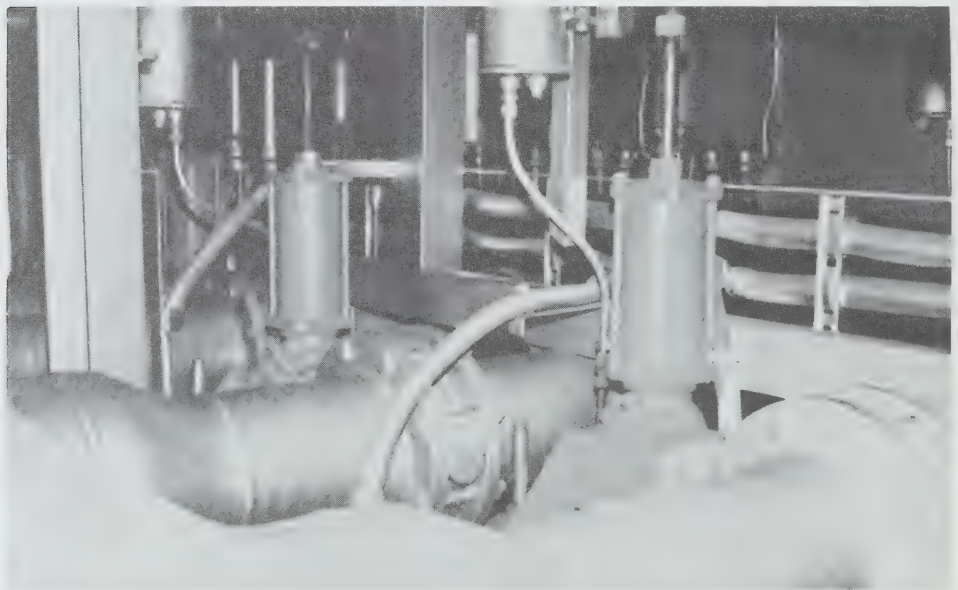
2.7 This photograph shows two of the remotely operated 18-inch butterfly valves in the pump room, which connected each ballast tank to the common manifold. Two other valves can be seen in the background, and the manifold is visible in the lower left-hand corner. These valves could be operated manually by using the threaded jackscrew at the top of the actuator.

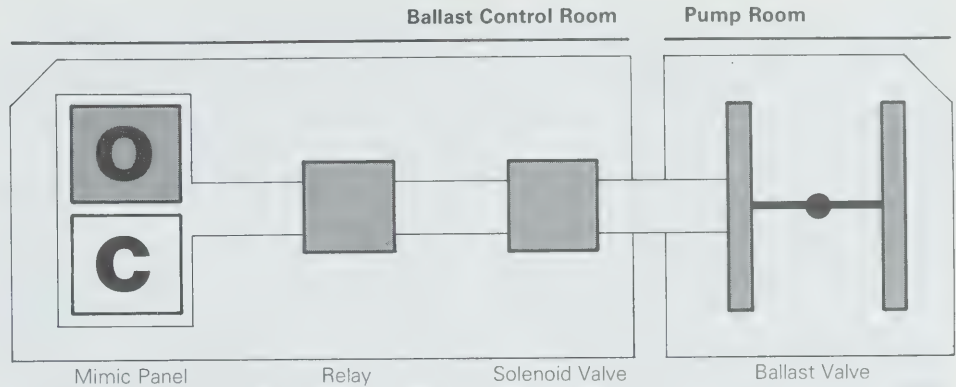
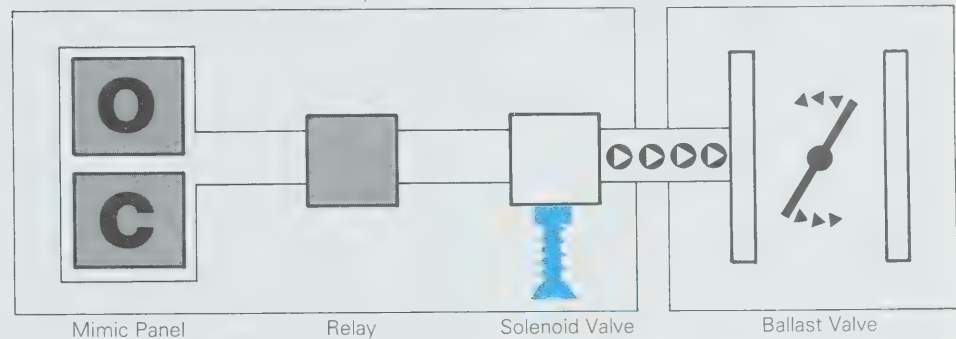
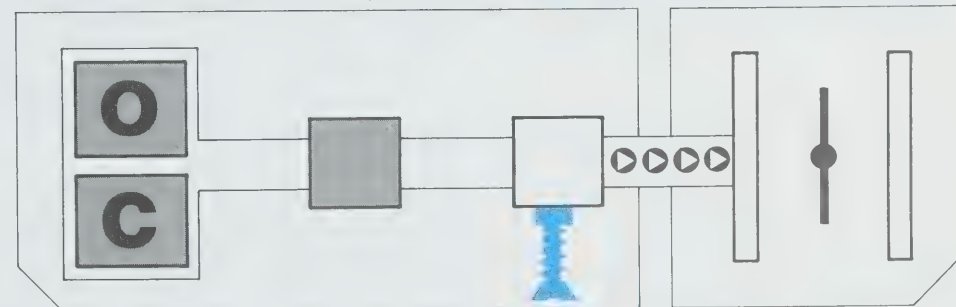
2.8 Ballast control operation using the brass rods.

VALVE CLOSED. The relay and solenoid valve are both in the unactivated position. A limit switch on the ballast valve actuator, connected to the indicator light through the relay, has illuminated the "closed" light.

BRASS ROD INSERTED. The solenoid valve is manually activated, causing the ballast valve to open within 20-40 seconds. As the valve starts to move and releases the limit switch, the "close" light is extinguished.

VALVE OPEN. With the ballast valve fully opened, the 'open' light remains extinguished because the relay is in the unactivated position. Opening the ballast valve in this manner does not require electrical power to the mimic panel.

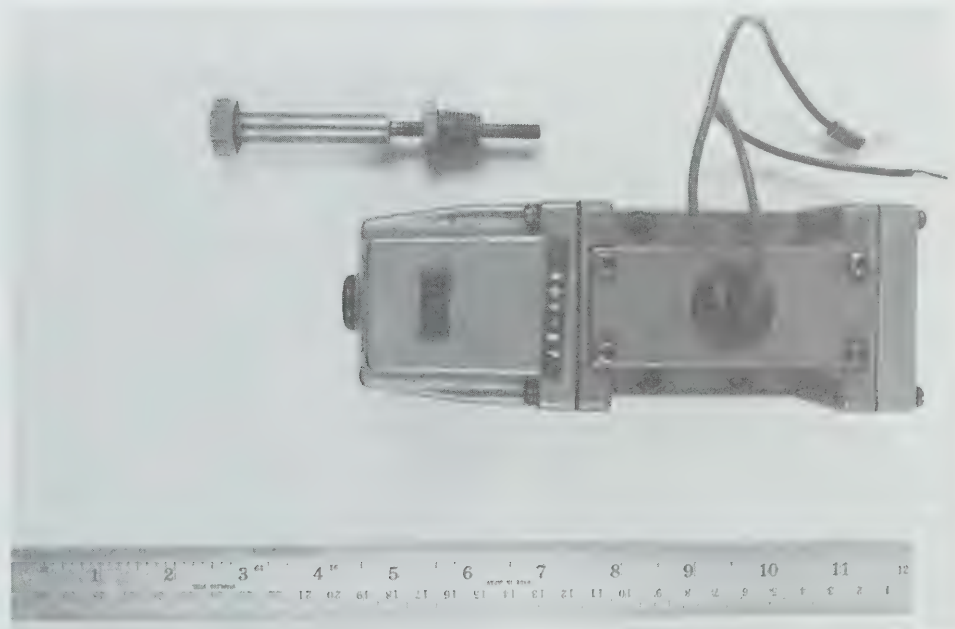
2.9 The solenoid valve on the right is one of the 64 recovered from the wreck. The black protrusion at the front of the valve is a plastic dust cover inserted in a threaded opening. Although the valve was normally opened electrically using the switches on the mimic panel, it could also be opened manually by pushing the solenoid core with a tool inserted through this hole. The brass rod at the top is one of at least eighteen that were placed in the ballast control room, during construction, for this purpose.

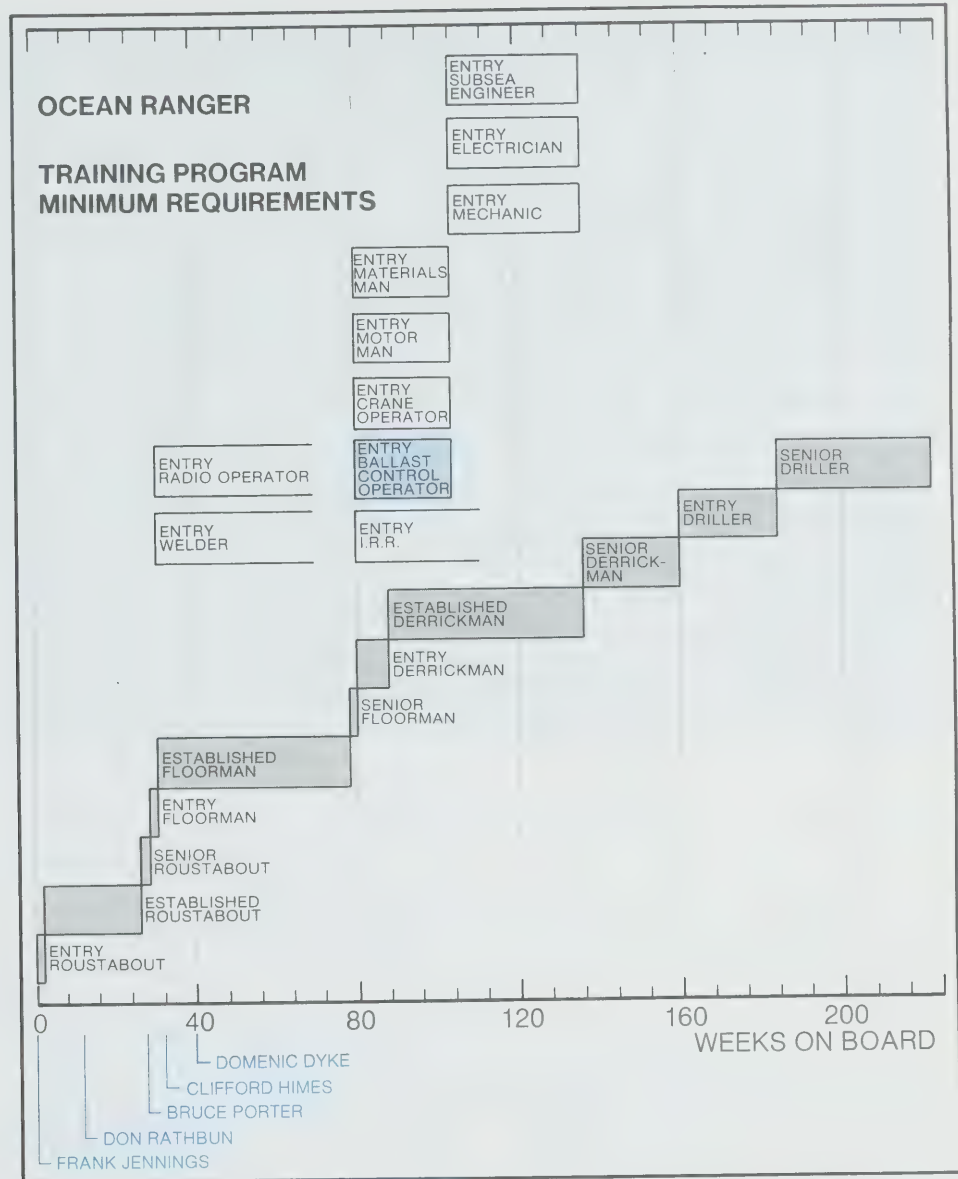
3.3 The ODECO training policy for the industrial crew required 80 weeks of experience before a crew member was recruited to train as a ballast control operator. This policy was not followed on the *Ocean Ranger*.

It is apparent that in practice the training of ballast control operators was at variance with ODECO's stated training program. The actual practice was to identify prospective candidates by the interest they expressed in training for the position. After he had completed his 12-hour shift the prospective candidate would be permitted to spend time in the ballast control room. No provision was generally made for him to work regular shifts as an understudy. When he had demonstrated to the experienced ballast control operator and to the master that he had the necessary skills and understanding to operate the mimic panel and to complete the daily calculations and the stability log, his appointment as a full-time ballast control operator would be recommended to the toolpusher. He would have had no courses nor would he have to pass tests, formal or informal, to determine whether he understood the system. The only requirements were an elementary understanding of how the system operated, the mechanical skill to operate the system through the use of the mimic panel, and the ability to make simple stability calculations. The training program did not provide an understanding of the electrical and mechanical operations of the bal-

last control system nor the effects of ballast gravitation. A thorough knowledge and understanding of what might go wrong and how to detect and remedy the situation were also lacking. The training emphasis was based on the erroneous assumption that the ballast system was fail-safe.

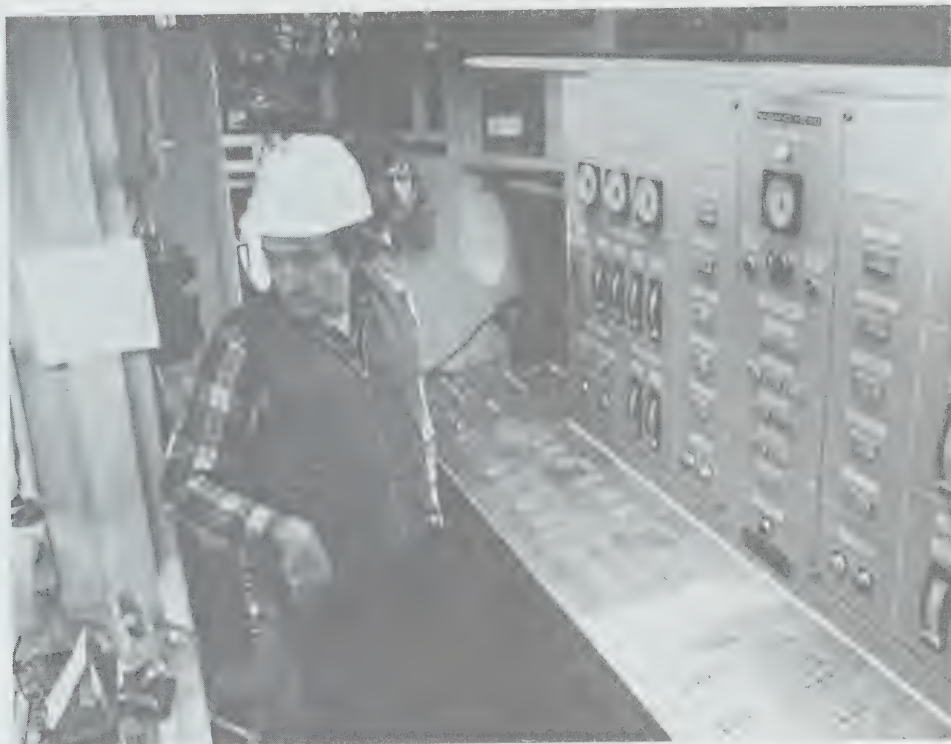
3.4 Ballast control operators at work in the ballast control room. The photograph shows the confined working area in the room; an Aldis lamp, used for illuminating the draft marks at night, can be seen on the port section of the mimic panel in front of porthole #3. The handset for the rig-wide public address system is visible at the extreme left.

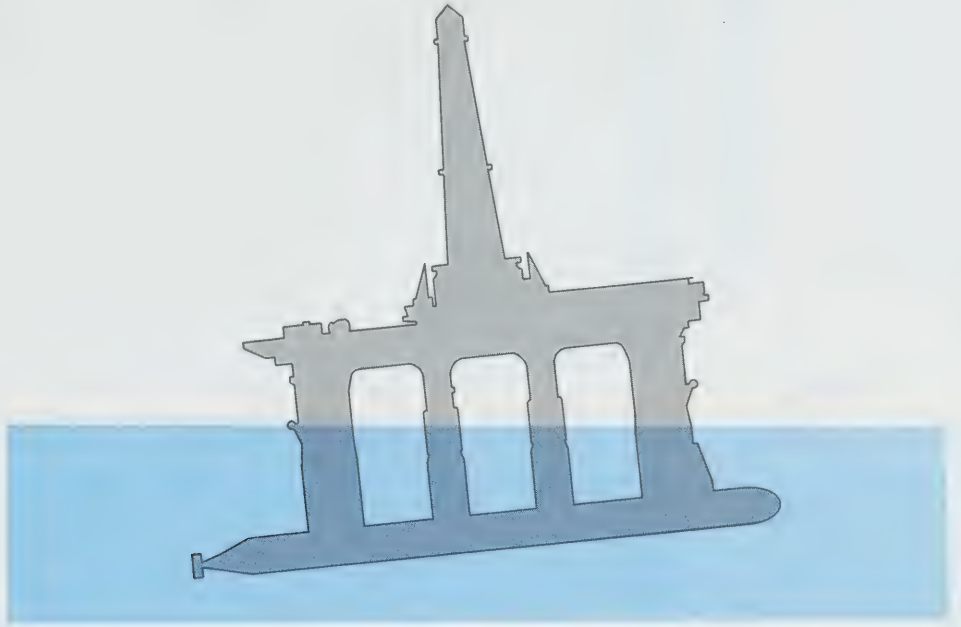
4.5 The *Ocean Ranger*, illustrated with a 6 degree stern trim, at the 80-foot draft, giving some indication of the severity of even relatively small trims.

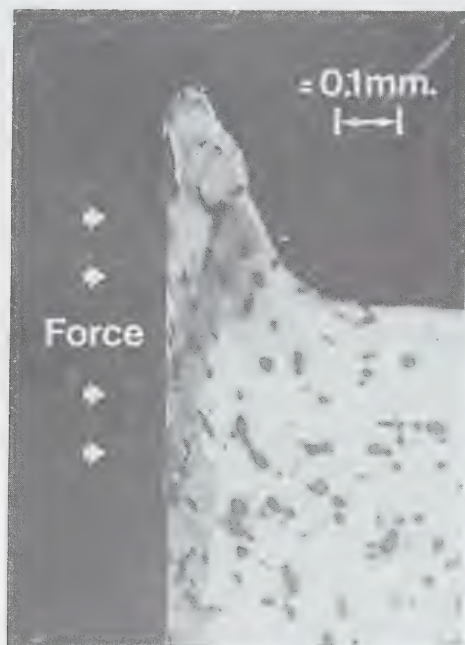
6.2 This photomicrograph shows the distinctive lip of metal discovered around the entire circumference of the locking ring from porthole #4. The lip and the pattern of deformation at its base indicate that the portlight was broken in the inboard direction by high impact loading evenly distributed over the entire glass surface.

The two damaged portholes were examined to determine the cause of the failure of the portlights. The one intact portlight was tested to determine the breaking strength of the glass (Appendix F, Item 3). Both damaged portholes were disassembled and the locking rings which held the portlights in the frame were inspected for signs of deformation that might indicate the forces involved in breaking the glass. The locking ring from porthole #4 exhibited a pronounced "lip" of metal on the edge of the ring that had been adjacent to the portlight; the locking ring from porthole #1 was undamaged. It was concluded from a subsequent metallurgical examination of the deformation that the portlight in porthole #4 had been broken by wave impact of short duration and great force. The lack of a similar deformation in the locking ring from porthole #1 indicated that the portlight had been subjected to a slowly increasing pressure over a longer period and that it had been broken by static water pressure and possibly debris impact during the sinking of the rig.

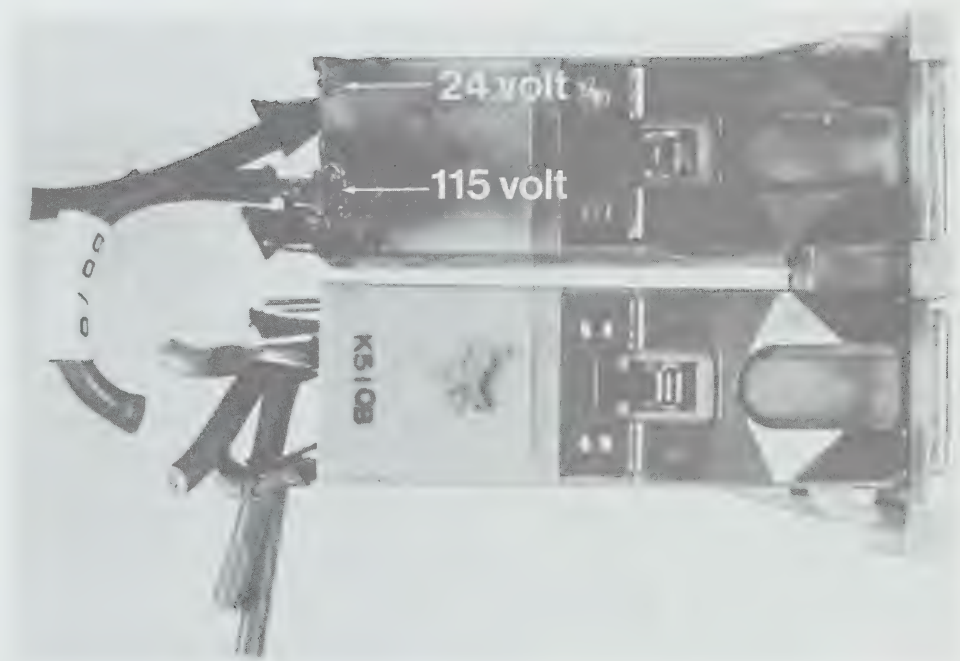
6.6 Valve control switch P-19 was the only mimic panel component which was visibly damaged. The melted area near the base of the housing was caused by a short circuit between the 24-volt and 115-volt terminals.

The failure of the pump switch indicator lights, which were connected to a separate 115-volt circuit through a 115-volt/18-volt transformer in the body of each pump switch, was attributed to short circuiting of these transformer terminals. Each pump switch was equipped with a rubber gasket that prevented sea water on the surface of the mimic panel from entering the switch housing. Tests showed, however, that water could seep from the surface of the mimic panel through the valve switch

openings and enter the pump switch housings, short-circuiting the transformers and causing the bulbs to fail because of excessive voltage.

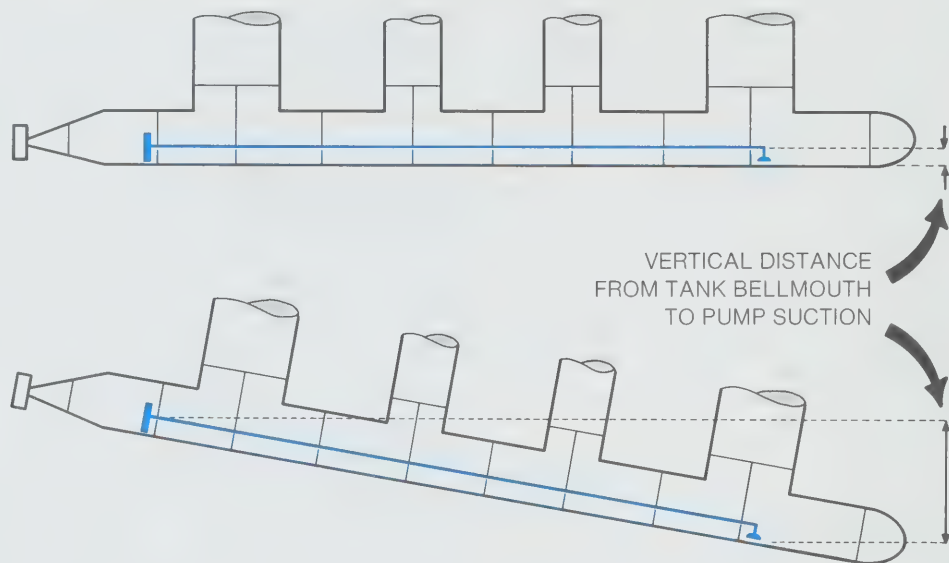
6.8 As the rig trimmed to the bow the vertical distance between the suction inlet in the tank and the suction inlet at the pump increased, reducing the ability of the system to pump out the forward tanks.

The effect of these design weaknesses on the rig's ballast system would have seriously hampered any attempts to right the rig from the severe trim reported on the night of the loss. The rate at which ballast could be pumped from the bow tanks would be reduced to zero as the trim progressed. In normal operations, the rate of flow from a given tank is unimportant; under the circumstances which existed on the night of the loss, the flow rate from the bow tanks was a critical factor.

diameter suction lines in the system would also have helped. ODECO has indicated that this consideration is included in all of their current designs.

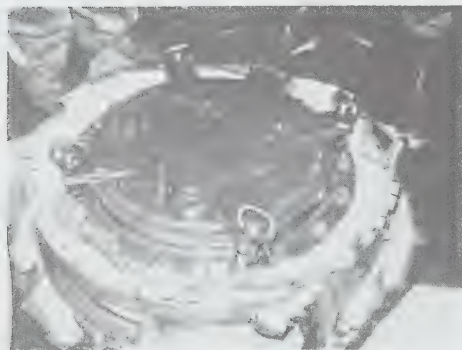
7.1 One of the three portholes removed from the wreck. The deadlight was closed and dogged.

There is no doubt that the breaking of this portlight, sometime between 7:45 and 8:00 p.m., was the first link in the chain of events leading to the loss of the *Ocean Ranger*. Evidence indicated that the thickness of the glass, as specified on the plans furnished by the supplier of the portlight, was insufficient to withstand the wave forces under predictable extreme storm conditions and, moreover, that as the glass aged, pitting of its surface by water-borne or air-borne particles would diminish its strength. In addition, the installed glass failed to meet even the standard of thickness specified on the plans.

The size of the lip on the locking ring of portlight #4, which broke before the capsizing, was approximately twice the size of the lip on portlight #2, which was recovered intact, after the latter was tested to glass failure at 68 psi. Testimony was given that the pressure necessary to produce a lip of the magnitude found on portlight #4 would be at least twice that amount. It was suggested by counsel for ODECO that the force of a wave alone was unlikely to approach that pressure and argued that the portlight was broken by heavy wave-borne debris. He argued that since the debris would necessarily be carried at or near the water surface, the portlight would not be subject to a large head of water and therefore, little water would enter the control room. The technical examination of the portholes recovered does not support this argument. Research on shock pressures generated by breaking waves indicates that dynamic pressures in excess of 140 psi are possible for short durations.² Examination of the recovered portlight confirmed that the glass was broken by the application of uniform pressure over its entire surface and not by debris impact.

Each porthole, as designed and installed, included on the inside a metal deadlight which could be lowered and secured over the glass when it was anticipated that waves might break on the portlight, but there were no instructions for the use of these deadlights and no standing orders that they be closed during storm conditions. Testimony indicated that appropriate instructions have now been included where relevant in all ODECO manuals. Notwithstanding the absence of instructions, if the crew, acting in accordance with good seamanship and common sense, had closed the deadlights in the ballast control room before 7:45 p.m. on February 14 the first link in the chain of events would not have been forged and the loss of the *Ocean Ranger* and its crew would have been prevented. It must be recognized, nevertheless, that if full consideration had been given in the design of the rig to the severe environmental conditions under which the rig might be operating, several other links in the chain of events which led to the capsizing would not have been forged. For if the control console had been waterproof; or if it had been protected from any sea water that might come in through a broken portlight; or if the portlights themselves had been impregnable to the force of waves under predictable environmental conditions; or if the ballast control room had been located at a higher level on the upper deck and a system more sophisticated than draft marks attached to the columns had been provided for checking the draft, then, again, there would have been no chain of events and no loss.

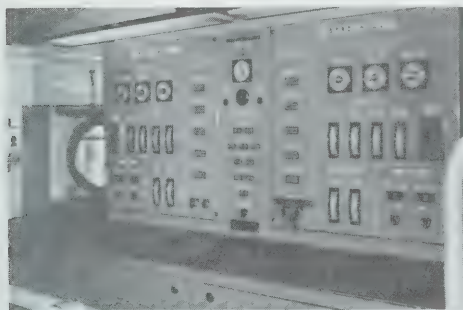
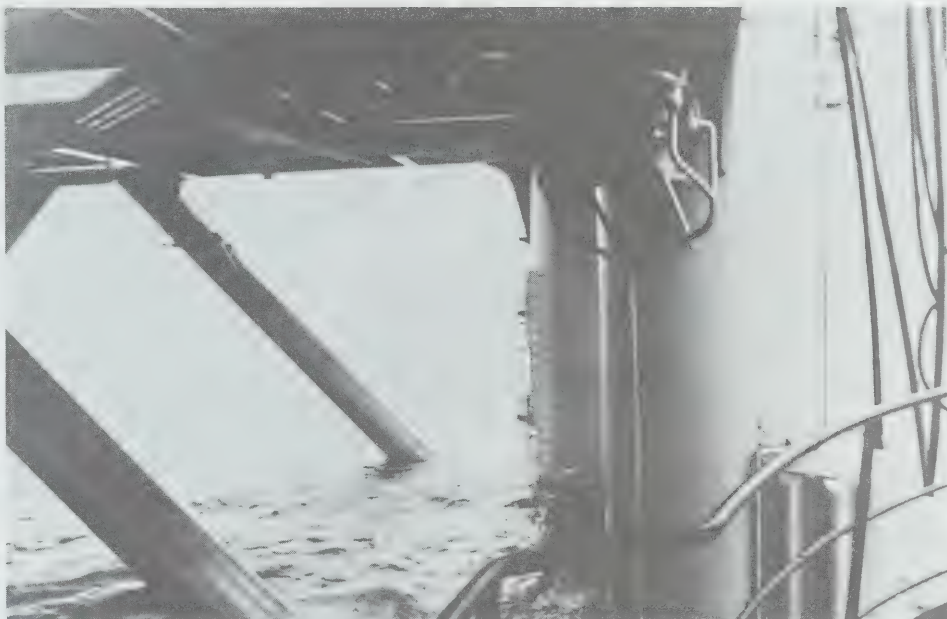
7.2 These photographs show the ballast control console and the view of the draft marks from porthole #3 at the extreme left.

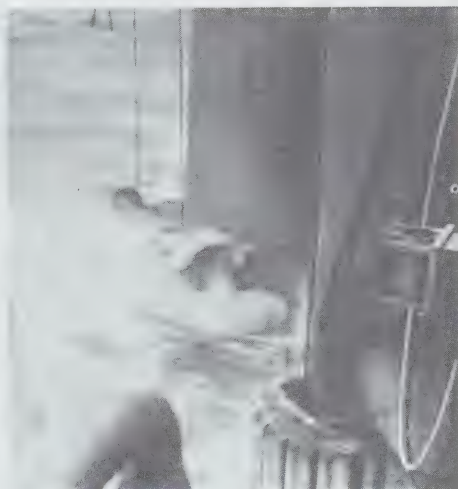
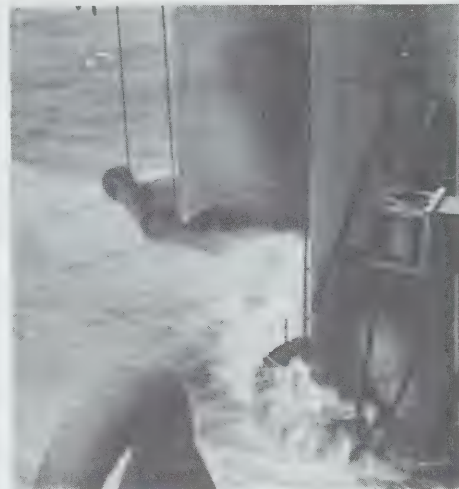
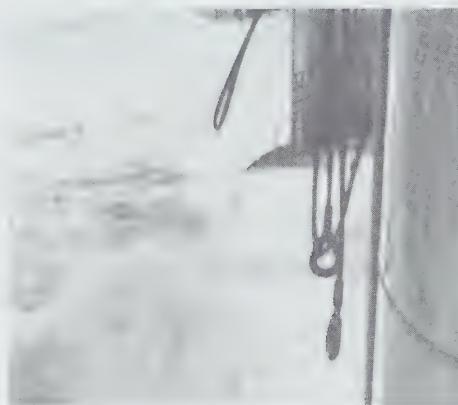
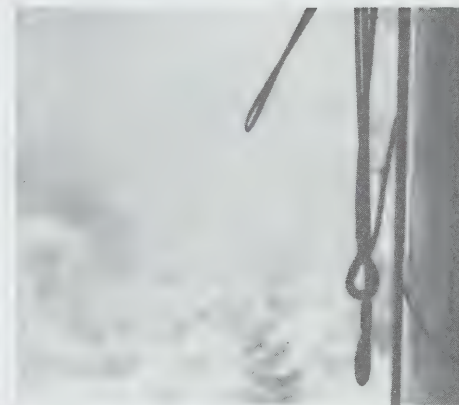
7.3 This sequence of photographs shows the ballast control room portholes obscured by spray during relatively light sea conditions. The photographs were taken from the windlass control house at the mooring platform on the starboard bow.

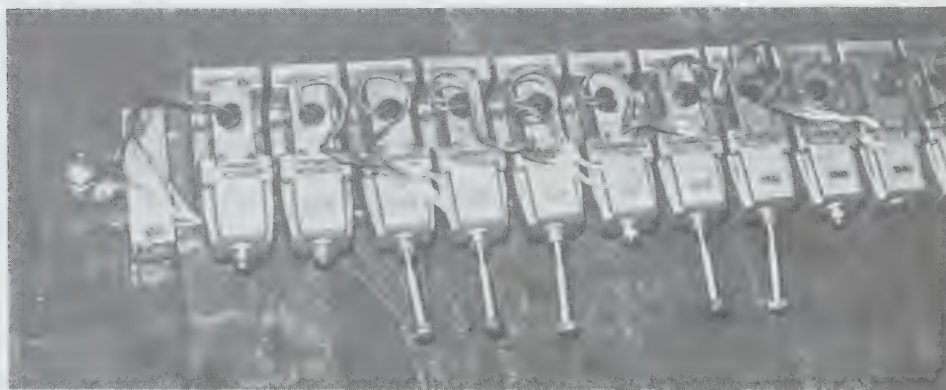
As previously noted, ODECO counsel argued that the microswitches did not in fact short-circuit. He suggested rather that at approximately 12:30 a.m. February 15, the ballast control operator inserted 18 manual control rods as a precautionary measure to ensure that the valves stayed closed. As previously discussed, the crew wrongly believed that insertion of a rod would close a valve. The reverse was true. Computer calculations prepared by Mr. Ralph Loomis, an ODECO engineer, indicate that after insertion of the brass rods gravitation between tanks would eventually

It is difficult to accept the argument by ODECO counsel that the ballast control operator would insert the manual control rods as a precautionary measure if the ballast control console was operating normally. The operators on board had never used the rods and accordingly it is highly unlikely that they would have used them particularly when, as suggested by ODECO, deballasting had been completed and no further ballasting operation was required or anticipated. The insertion of the rods as a precautionary measure suggests a degree of planning and thought that is not consistent with the manner in which the rods were actually used. Since the crew must have recognized that there were not enough rods to complete the task, it is not logical to suggest that they would be used to carry out a planned operation. The insertion of three rods into solenoid valves affecting drill water tanks also suggests a hasty rather than a planned activity. Furthermore, the crew knew that the simple alternative of removing power from the panel would cause all valves to close. It was unlikely therefore that they would resort to a previously unused precautionary measure. If the rods had been inserted as a precautionary measure after the use of the panel for one hour to deballast, it would have been contrary to the established patterns of behaviour of the ballast control operators under normal conditions. Furthermore, since counsel for ODECO suggests the panel was functioning normally, the insertion of the rods would have been the only unusual action taken affecting the panel. It is likely, therefore, that the insertion of these rods would have been seen as contributing to the cause of the trim, in which case the crew would undoubtedly have removed them. The evidence shows that none of the rods was in fact removed and that the crew was "trying to isolate the problem." Insertion of the rods as found could result only in gravitation. This changes the longitudinal moment of the ballast but has no effect transversely; a forward movement of water in the port pontoon would cause a forward trim, but not a port heel. The reports of a port list are inconsistent with difficulties caused only by gravitation and no water ingress. The rig must, therefore, have been subject to ingress of water from the sea, not gravitation alone as suggested by ODECO.

7.6 One of the six banks of solenoid valves recovered from the ballast control console. Many of the brass rods were broken during salvage, leaving only the brass bushing and a section of the threaded rod at the front of the valve housing. The valve on the extreme right is fitted with a plastic dust cap.

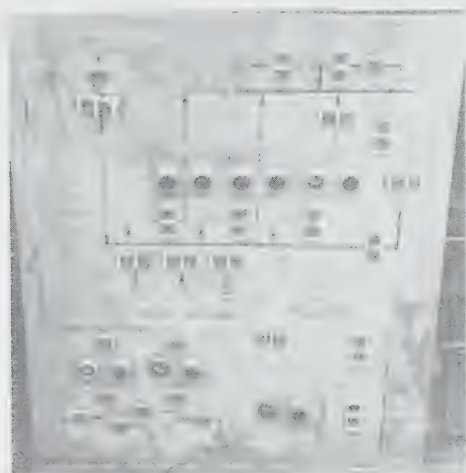
Examination of the recovered mimic panel and switches provided a reliable indication of the distribution of water and of the extent of damage to the ballast control

panel. Testing indicated that those indicator light bulbs which did *not* fail survived because sea water elsewhere in the switch provided an alternate path for the 115-volt current, other than passing through the 24-volt bulb filament, thus protecting the filament from the effects of overvoltage. These intact bulbs were distributed randomly across the panel indicating a wide horizontal distribution of water. None of the damaged bulbs had been replaced, and the potential for continued short circuits within the switch housing indicates that the 24-volt indicator light circuit was never restored to normal operation. Another indication of the effects of sea water on the mimic panel was the burning and melting damage found at the plastic base of switch P-19 which controlled a remotely operated valve on the discharge side of the port drill water pump. This damage was caused by the collection of sea water at the base of the switch in a quantity sufficient to maintain a short circuit for the time necessary to cause the melting to the extent that was found. There was no indication of any attempt to replace this switch which, as recovered, was inoperable.

One 18-volt bulb in each pump switch pair was found to have failed, again because of an application of excess voltage, in this case, within the pump switch itself. Ingress of water into the affected pump switches required a wide horizontal distribution of water across the panel. Only 10 of the 24 individual pump switches were completely assembled when recovered and, of these, only the switch pairs controlling port pumps #3 and #5 were complete. Fourteen switches were without the coloured lens and in some cases the lens guard as well. The absence of the lens makes the switch difficult to operate. It is apparent from the condition of these switches that they had not been restored to normal operating condition before the abandonment of the rig.

7.7 One of the four mimic panel sections recovered from the ballast control console. Only the pump switches for port pumps #3 and #5 had been reassembled.

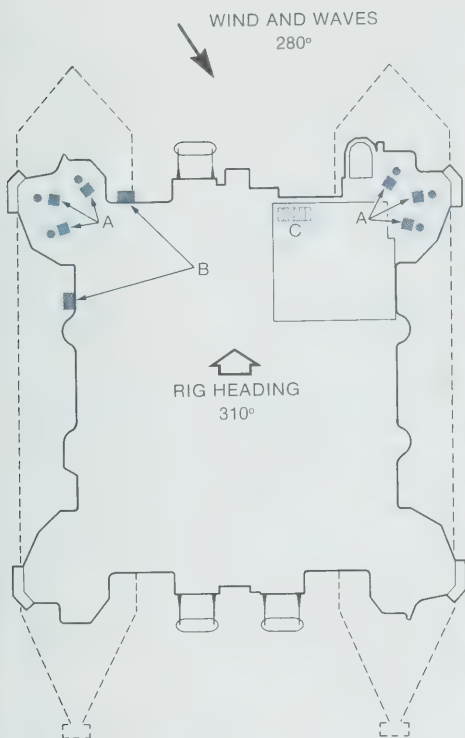
As the forward portion of the upper deck became lower, its cargo and deck fittings became exposed to the severe wave action. Drill pipe and storage huts were washed overboard and air vents leading to the sack storage area in the lower deck were broken, allowing water to flood into the lower deck area. One of these vents was located on the bow on the port side, while another was located on the port side forward. It is believed that one or both of these vents were broken off by wave action or by shifting deck cargo. It is also likely that water flooded from the lower deck into the column spaces above the chain lockers, into the accommodation areas through damaged portions of the superstructure and thence into the lower deck area, and into the lower hull tanks through exposed vent lines. Whether or not any of this damage and flooding occurred before the decision to abandon is unknown. The flooding would have created an unstable situation and the *Ocean Ranger*, dynamically assisted by wave motion, capsized and sank at approximately 3:15 a.m., February 15, 1982.

7.8 The illustration shows the location of the chain locker openings (A), the ventilators (B) and the accommodations area stairwell (C); the photograph shows one of the large bow ventilators which led to the sack storage area below. With a severe port bow list, drill pipe and deck cargo would have shifted, causing damage to the ventilator and allowing sea water to flood the lower deck.

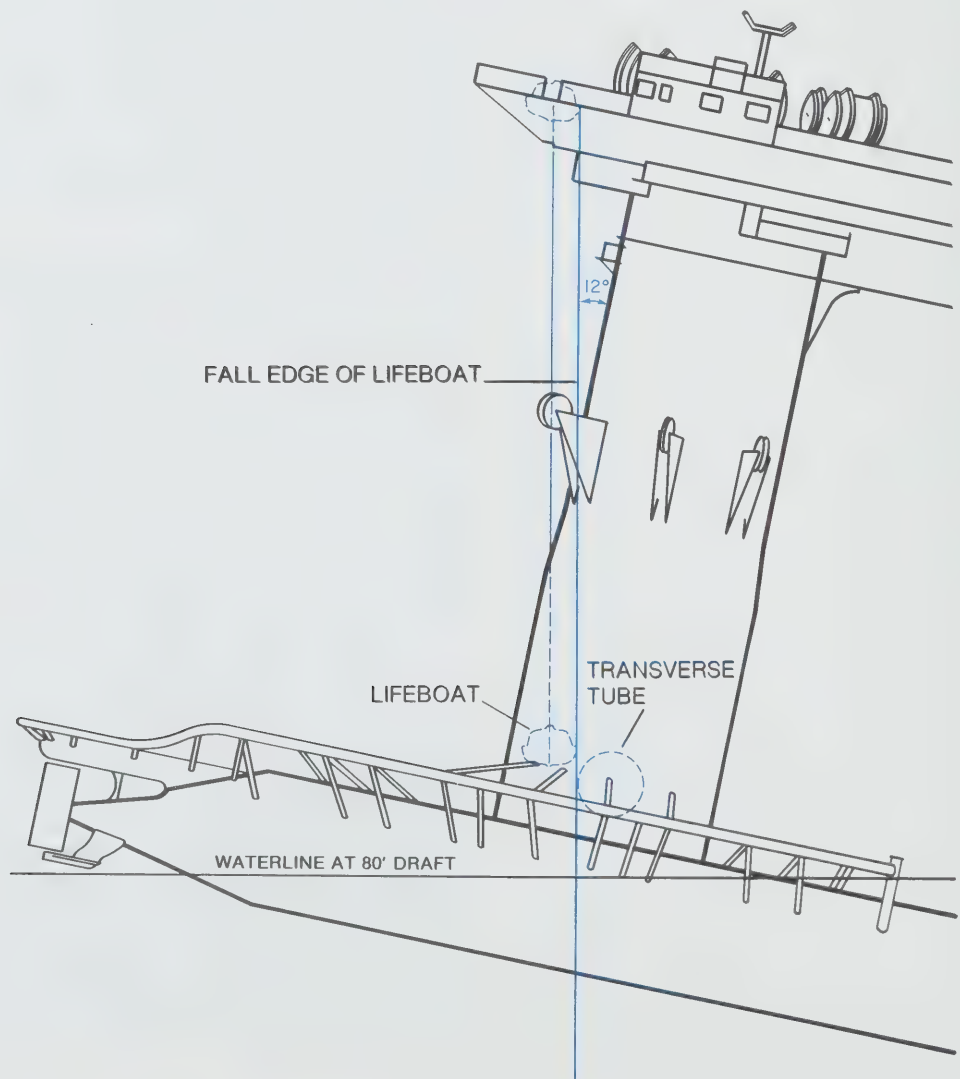
9.1 This illustration is taken from the ODECO installation plans for the Watercraft lifeboats. The design limitation for safe launching is illustrated at a 12 degree bow trim. The pitch and roll of the rig in heavy seas would restrict safe launching to a much smaller angle.

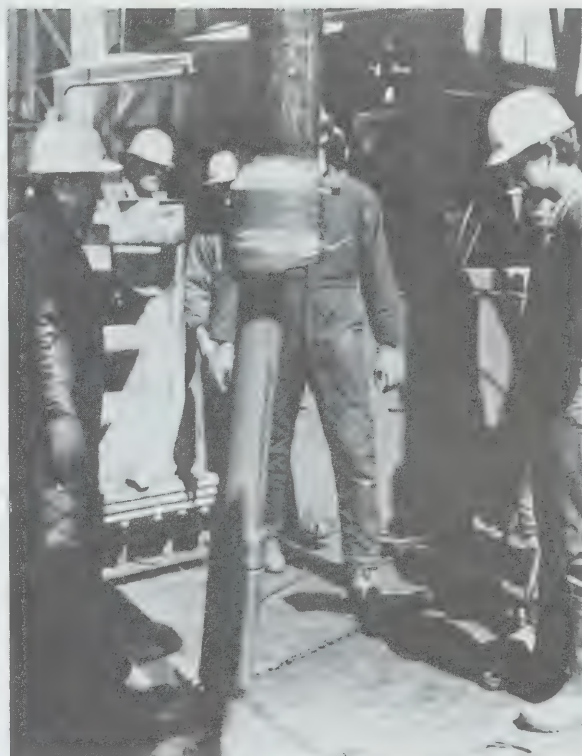
FIGURE 6 Mill pulled from hole with sheared pipe wedged in its throat. Note top of hang-off tool.

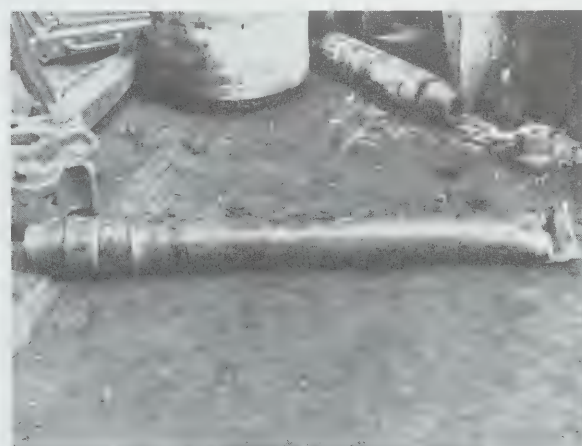
FIGURE 8 Sheared pipe removed from mill.

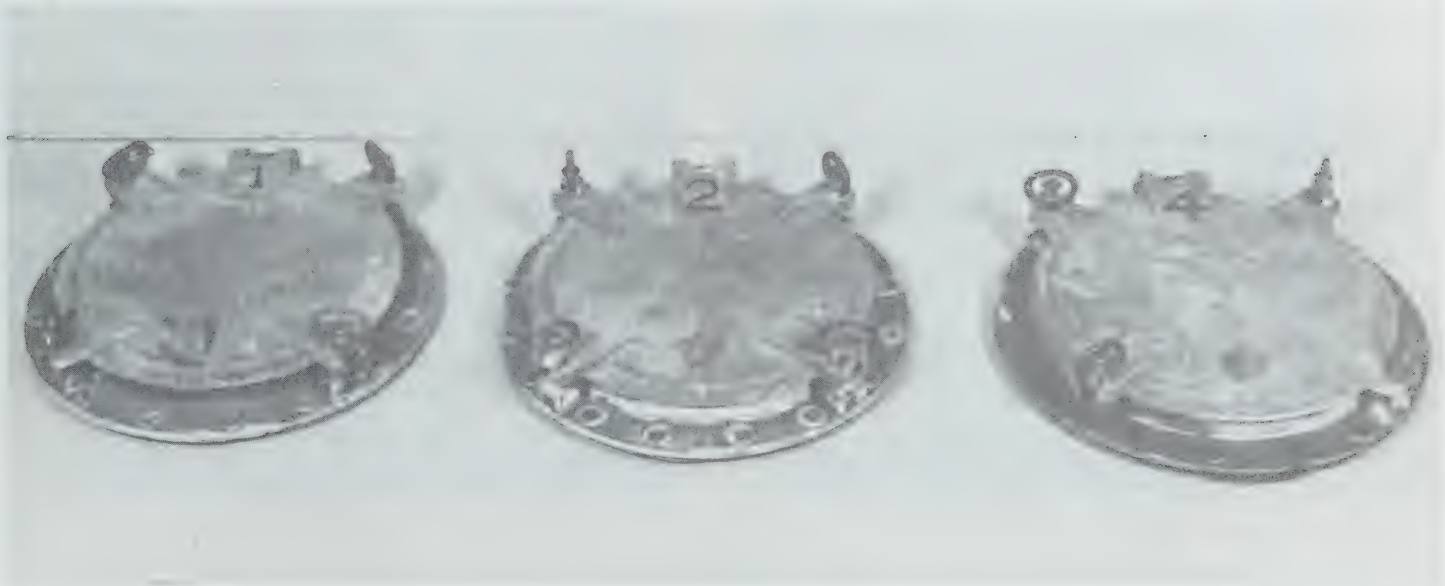
4.8 The deadlight bolts on portholes 1, 2 and 4 were hand tight, and no significant break away torque values were recorded.

PHOTO 1 Portholes as received with deadlights closed. Identified by the numbers 1, 2 and 4.

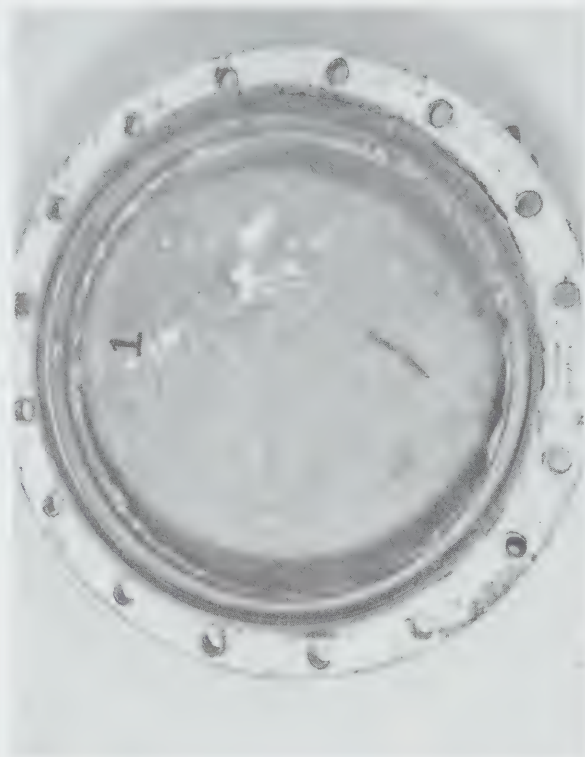
PHOTO 3 Porthole No. 1 with deadlight closed, view looking inboard.

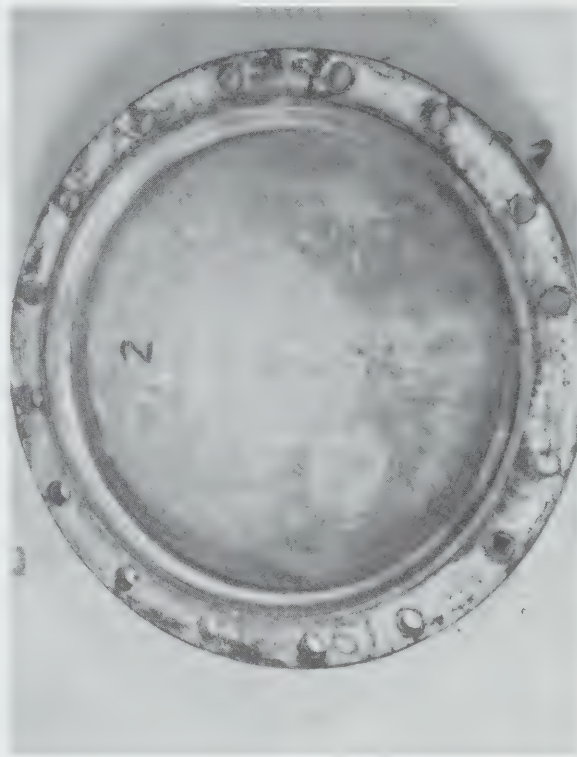
PHOTO 5 Porthole No. 2 with deadlight closed, view looking inboard.

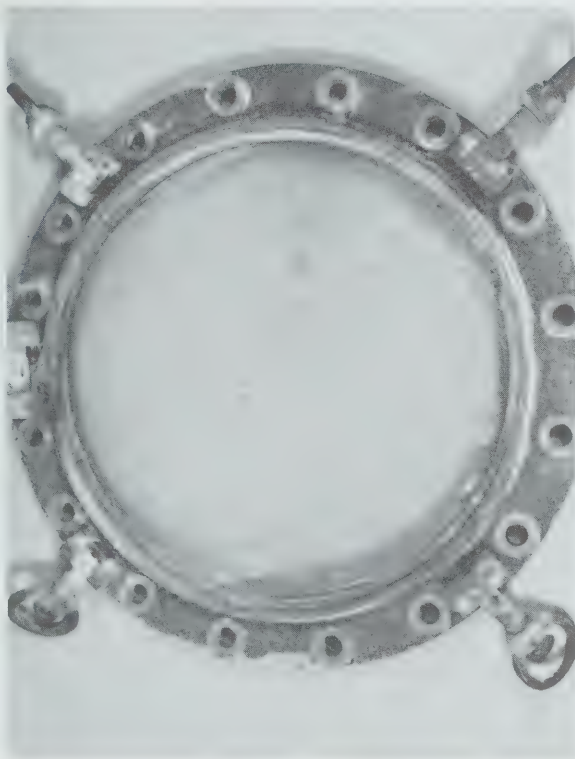
PHOTO 6 Porthole No. 2 with deadlight open, view looking outboard.
Note glass intact.

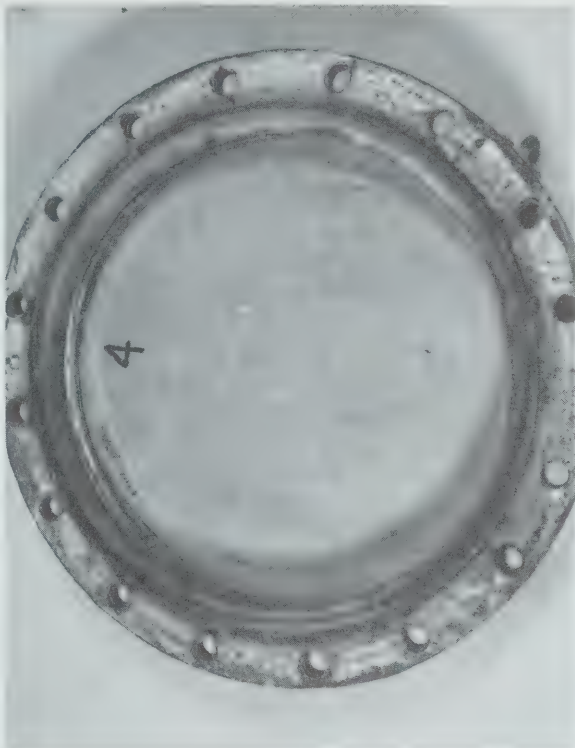
PHOTO 7 Porthole No. 4 with deadlight closed, view looking inboard.

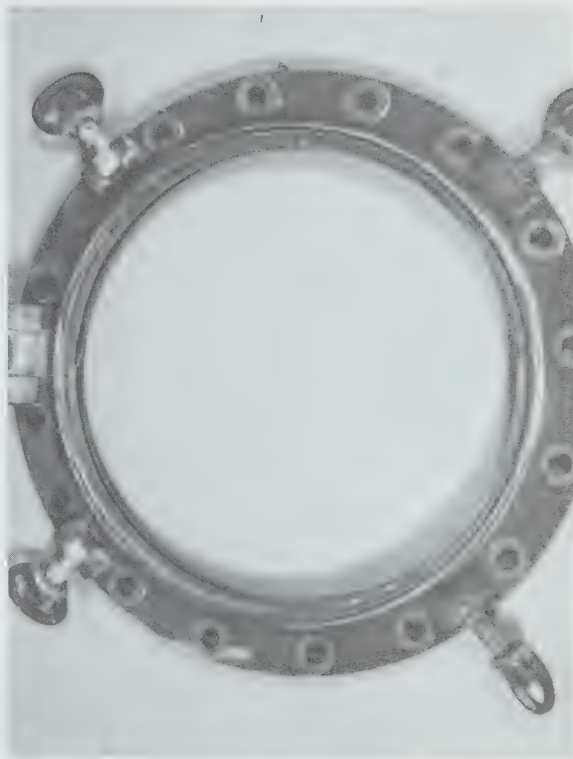
PHOTO 8 Porthole No. 4 with deadlight open, view looking outboard.
Note glass completely removed, no fragments.

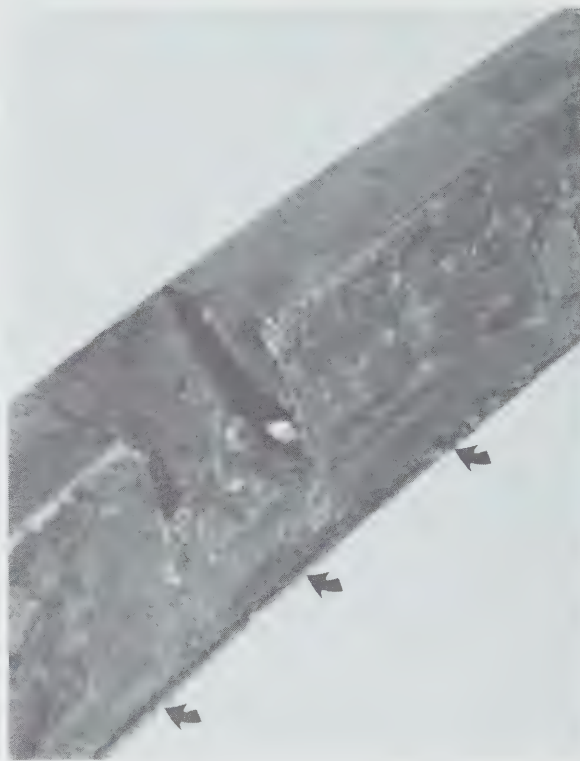
PHOTO 13 Glass locking ring from porthole No. 4 shows protruding lip of material along the inside edge (arrows).

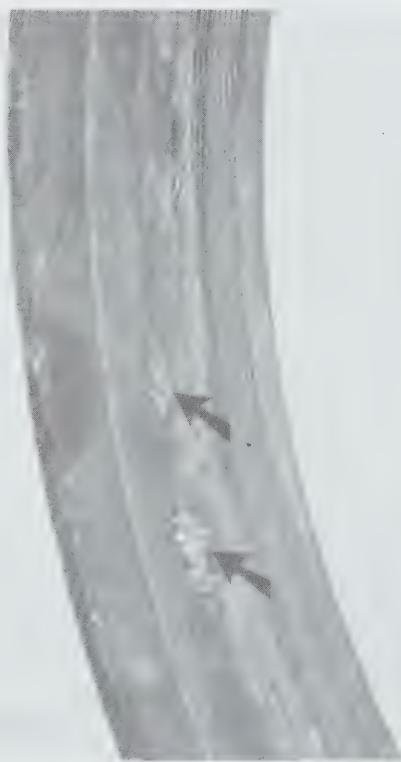
PHOTO 10 Porthole No. 4 showing impact marks and gouges (arrows) on the outboard edges of the porthole.
